Eleventh U.S. National Conference on Earthquake Engineering
Integrating Science, Engineering & Policy
June 25-29, 2018
Los Angeles, California

THE 2016 CENTRAL ITALY EARTHQUAKE SEQUENCE: OBSERVATIONS OF INCREMENTAL BUILDING DAMAGE

R. De Risi¹, A. Sextos², P. Zimmaro³, A. Simonelli⁴, and J. Stewart⁵

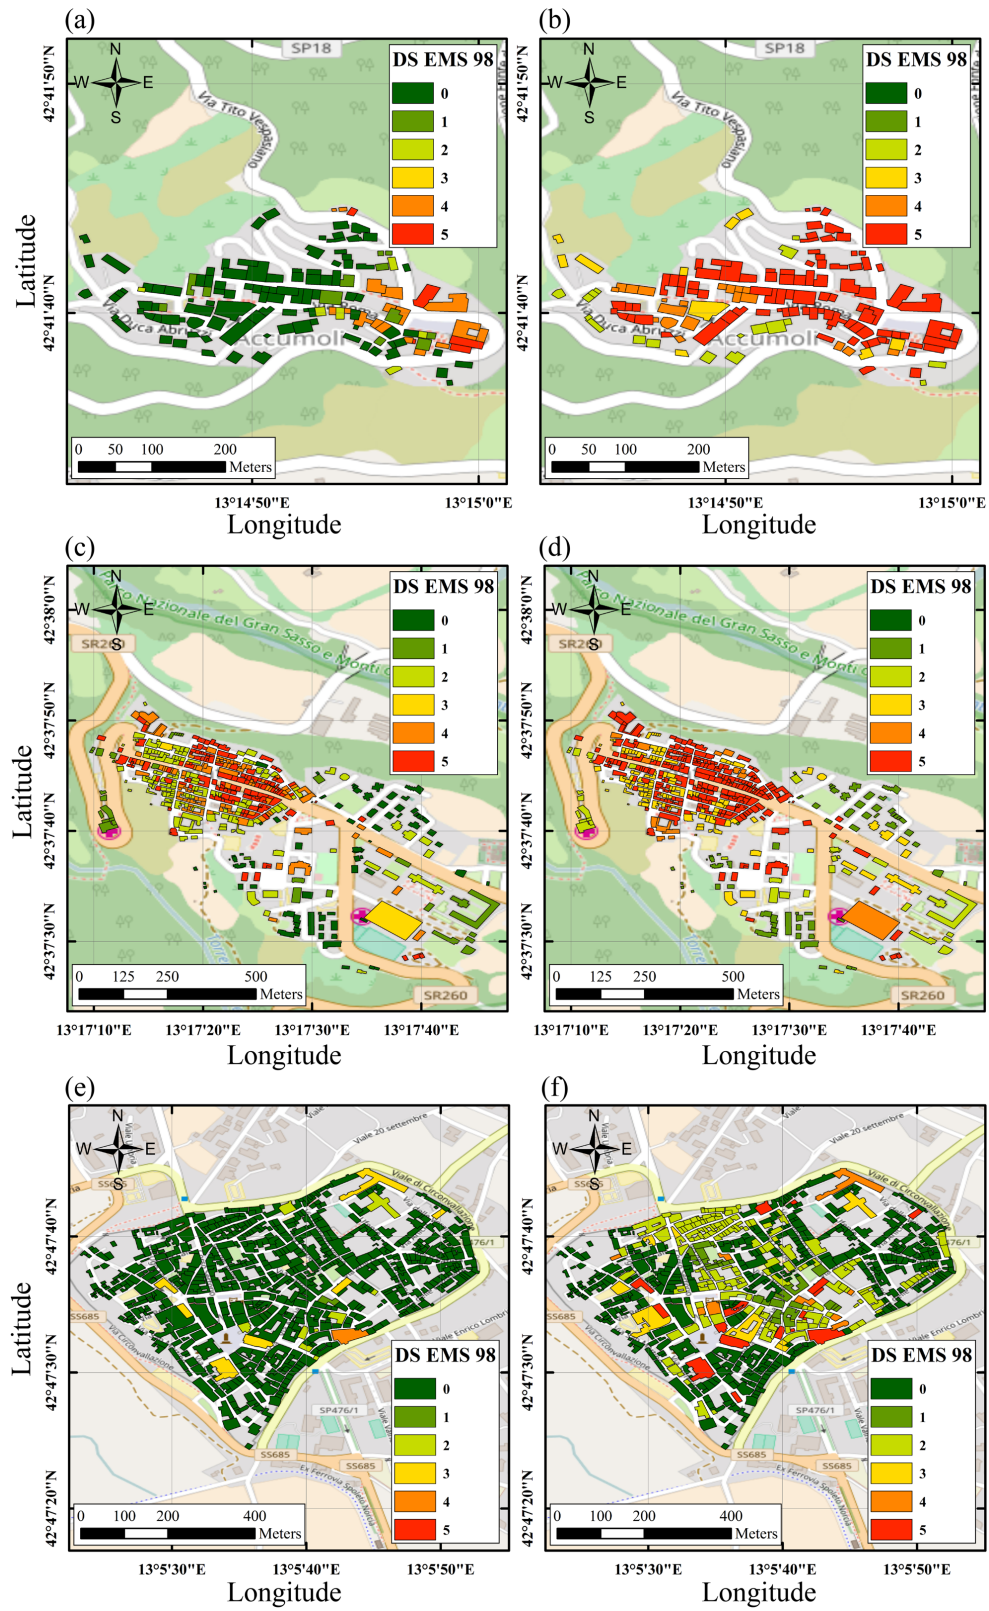
Figure 4. Damage observed in (a,b) Accumoli, (b,c) Amatrice, and (c,d) Norcia during the first (a,c,e) and the second (b,d,f) survey, respectively.

census, the building portfolio was mainly composed by old, two to three-story buildings that were constructed more than hundred years ago but were reported as having a good or “optimum” status of conservation. Figure 4 shows the structural damage assessed in terms of EMS 98 [12], as it was observed during the two surveys in Accumuli, Amatrice, and Norcia. The first two show an abrupt increase of structural damage under multiple earthquake events, while most buildings in Norcia retain a residual level of capacity. In all cases though, it is observed that structural damage of URM buildings does not follow a linear pattern of increase but accumulates disproportionately during multiple earthquake excitations due to the inherently brittle nature of masonry and the lack of appropriate retrofit measures. In regions such as Norcia where some retrofit schemes had been applied, the above degree of damage increase is relatively lower. Overall the following variation of damage have been observed after the first and the third major earthquake events: from 65.4% to 38.7% for DS0 (no damage), 2% to 2.3% for DS1 (minor damage), 11.9% to 16.2% for DS2 (minor-to-moderate damage), 0.6% to 11% for DS3 (moderate-to-major damage), 9.1% to 3.1% for DS4 (major damage), and a major shift from 11% to 28.7% for DS5 (collapse).

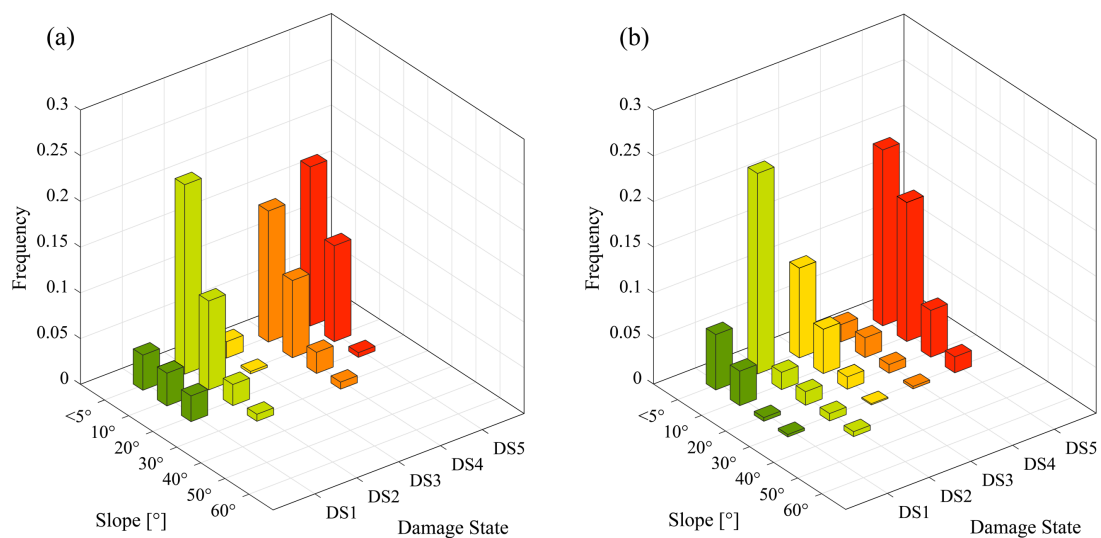
To understand whether there is a correlation between the observed damage and the local topography the rank correlation was calculated by means of the Sperman’s rho [15]. More specifically, for each building an intersection between the building footprints and the slope maps has been carried out. The slope value was then analyzed with respect to the damage state classification that was reported during inspection leading to a positive correlation of 0.19 and 0.38 for the first and the second survey, respectively. This observation indicates that the slope is potentially a useful proxy of the spatial distribution of damage. Figure 5 shows in more detail the distribution of the damage states as function of the local slope. It is possible to observe that when the slope increases, the frequency of occurrence of higher damage states also increases, thus highlighting the correlation between damage and topography for the case of the three towns examined.

Figure 5. Damage as function of the local slope; (a) after the first event and (b) after the entire sequence.

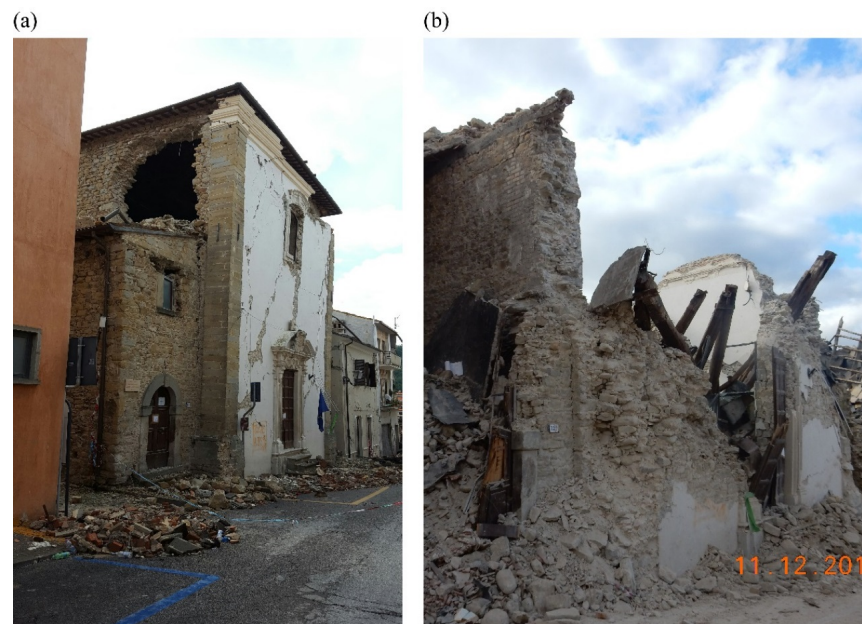
The typical evolution of damage on masonry buildings is shown in Figure 6, depicting a typical heritage building in Amatrice that experienced an incipient out-of-plane mechanism of the façade after the first shock, and eventually collapsed after the entire sequence. This is an example of a rapid evolution of damage during successive earthquake events that was very common in the case of Amatrice. Contrary to the previous observation, Figure 7 shows the evolution of damage for a masonry residential building in Norcia where a small increase of previously formed cracks can only be observed. This confirms that the evolution of cumulative damage of residential masonry buildings depends on the degree of repair and/or retrofitting measures that have been implemented, Norcia being a good example given the strengthening works (i.e., reinforced mortar, buttresses and connecting steel ties) that took place after the 1997 Umbria-Marche.

Figure 6. Masonry church in Amatrice after the (a) first and (b) second survey.

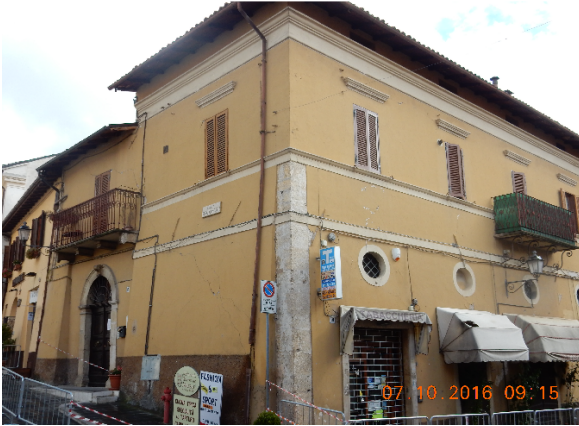
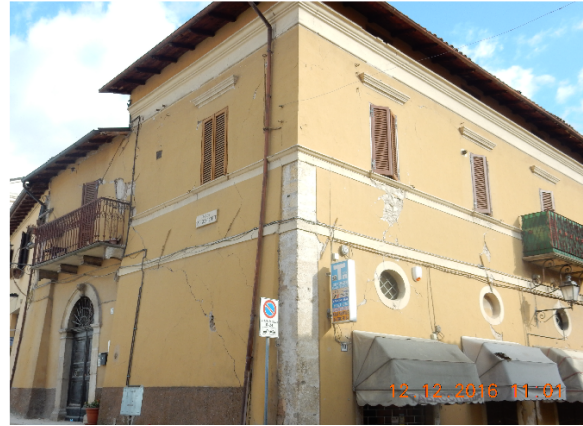
Figure 7. Masonry residential building (a) after the first earthquake and (c) after the entire sequence.

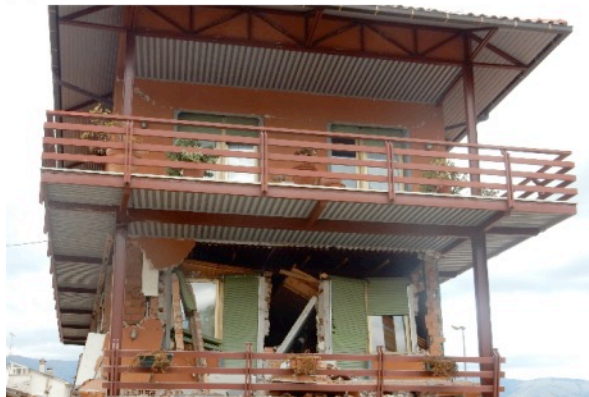
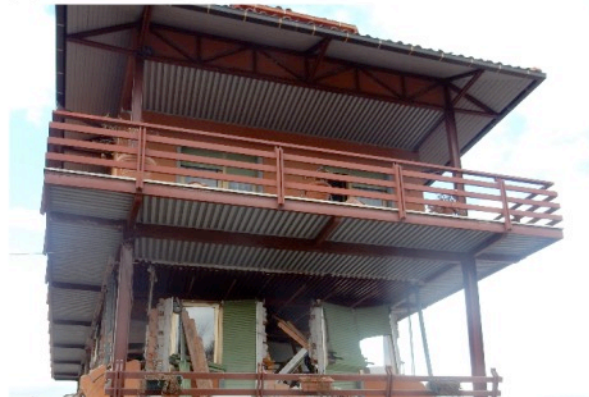
Amatrice's historical center (Figure 8). It was built in the early 90's according to the 1996 Italian seismic code [16] and consists of a basement, the ground floor, and two upper stories alongside a shorter top story that serves as a penthouse. More details about its structural and dynamic characteristics as well as the assessment of its seismic performance during the sequence of events can be found in [17]. After the 24 August event, the building mainly suffered cracks in the infill panels, with only small local flange instabilities observed at the top of two front columns of the ground floor. At the end of the entire seismic sequence, the building experienced evident permanent deformation along its longer direction, as shown in Figure 8. Such permanent deformation was localized at the second level of the building with a visible residual inter-story drift due to the relative positions of infills and openings. Preliminary finite element analyses of the building confirmed that the fundamental period of the structure is approximately equal to 0.75sec. This was an uncoupled translational mode along the long side, which was mainly attributed to the orientation of the steel columns with their strong axes aligned with the short side of the building. Naturally, residual drift developed along the longitudinal (weak) axis.

Figure 8. Steel residential building (a) after the first earthquake and (b) after the entire sequence. (a) Limited non-structural damage and (d) complete non-structural damage at ground level with consequent residual drift.

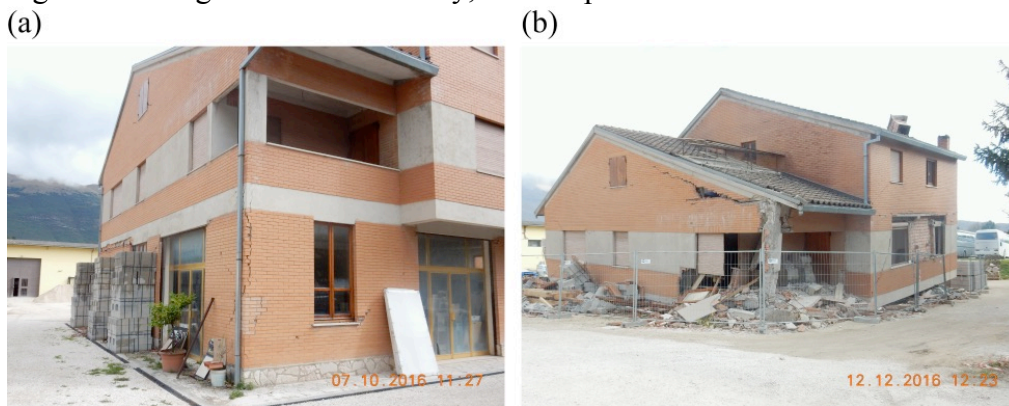
Reinforced concrete buildings, mainly suffered typical out-of-plane collapse of the infills, cracks in the beam-column joints and sporadic shear failures. Concrete spalling and buckling of longitudinal rebars was also observed. Even though the general trend was that damage in R/C buildings built up slower than in the case of masonry structures under multiple earthquake events, there were few cases where damage accumulation was abrupt. An example is the residential RC building in Norcia depicted in Figure 9 which only suffered shear failure in a single column after the first event, but experienced soft-story collapse during the third event. This was due to its high irregularity in both elevation and plan as well as its inadequate transverse reinforcement. Failure of such irregular buildings is common in Italy, as exemplified in the work of Verderame et al. [18].

Figure 9. Reinforced concrete residential building (a) after the first earthquake and (b) after the entire sequence.
