## ENGINEERING RECONNAISSANCE FOLLOWING THE AUGUST 24, 2016 M6.0 CENTRAL ITALY EARTHQUAKE

An earthquake with a moment magnitude reported as 6.0 from INGV (Istituto Nazionale di Geofisica e Vulcanologia); occurred at 03:36 AM (local time) on 24 August 2016 in the central part of Italy. The epicenter was located at the borders of the Lazio, Abruzzi, Marche and Umbria regions, about 2.5 km north-east of the village of Accumoli and about 100 km from Rome. The hypocentral depth was about 8 km (INGV). We summarize preliminary findings of the Italy-US GEER (Geotechnical Extreme Events Reconnaissance) team, on damage distribution, causative faults, earthquake-induced landslides and rockfalls, building and bridge performance, and ground motion characterization. Our reconnaissance team used multi-disciplinary approaches, combining expertise in geology, seismology, geomatics, geotechnical engineering, and structural engineering. Our approach was to combine traditional reconnaissance activities of on-ground recording and mapping of field conditions, with advanced imaging and damage detection routines enabled by state-of-the-art geomatics technology. We anticipate that results from this study,

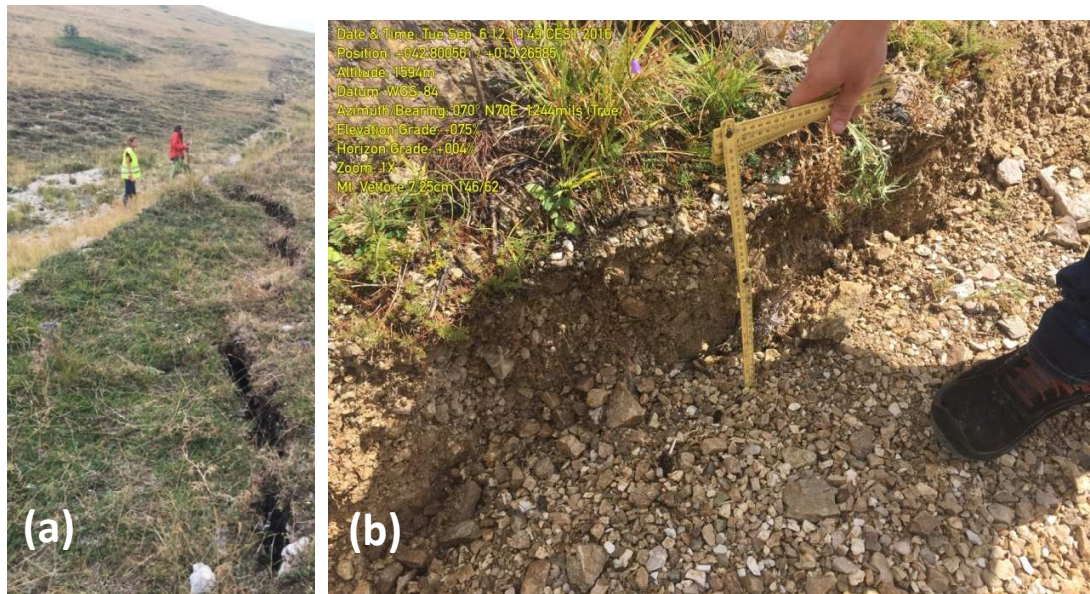
**Fig 3** – (a) photographs of surface rupture on trace of Mt. Vettore fault (N42.79953, E13.26634, 5 September 2016) and (b) typical measurement (N42.8056, E13.26585, 6 September 2016).

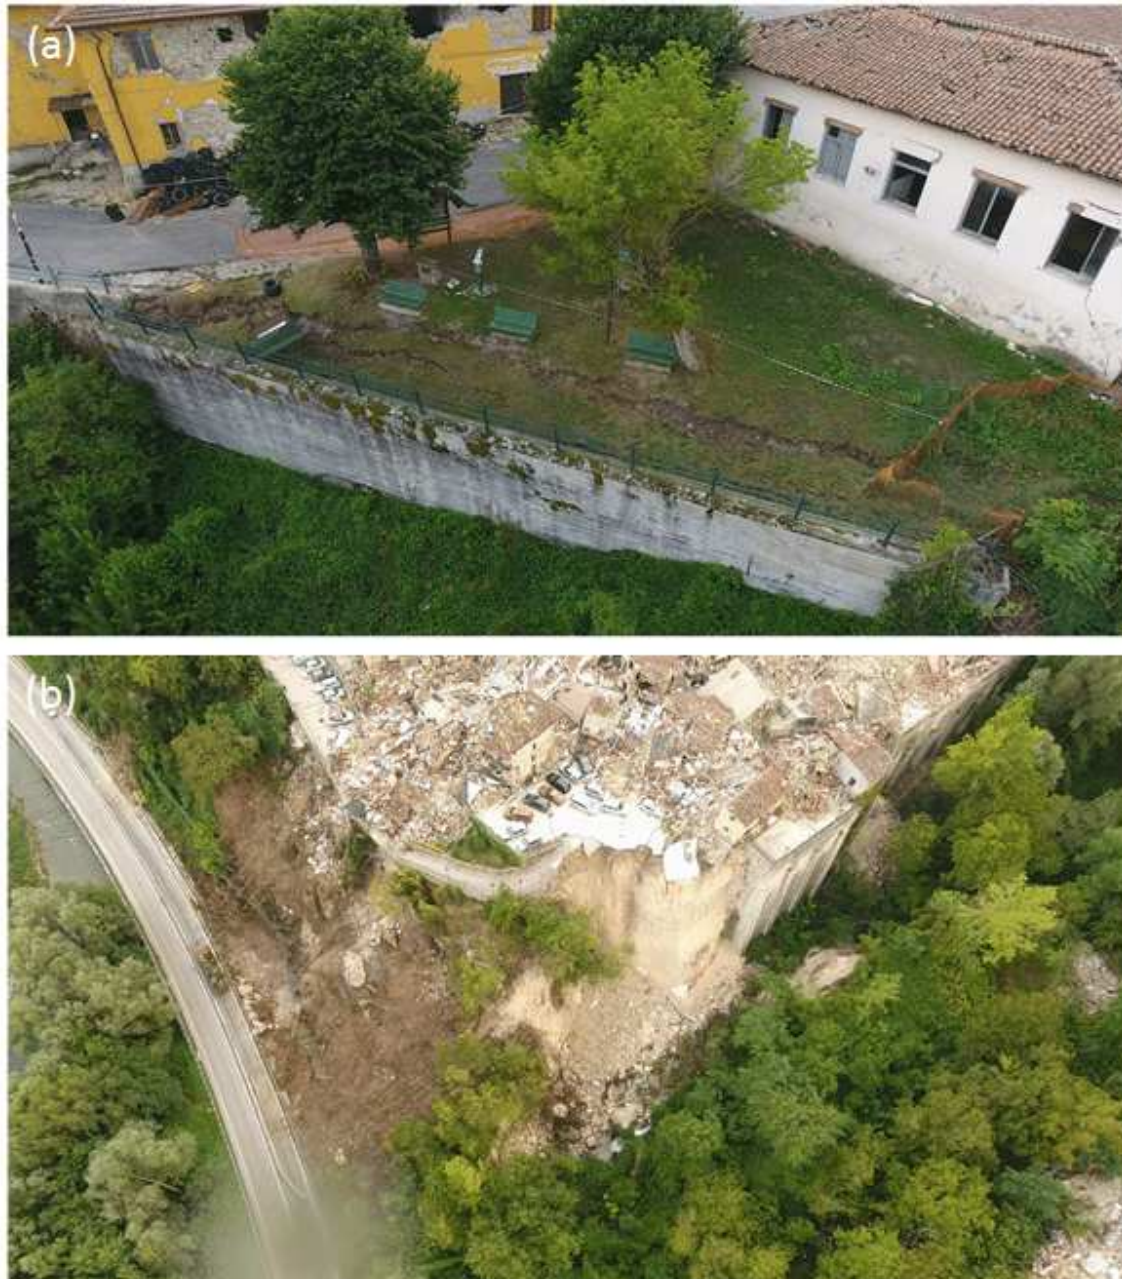
**Fig 6** – Aerial photos taken by drones at: (a) Accumoli (N42.69425, E13.24993, 9 September 2016); and (b) Pescara del Tronto (N42.750401, E13.272109, 9 September 2016).

Using a DJI™ Phantom 4 drone, a customized Align™ T-Rex 800 drone, and an Ebee Sense Fly drone, we imaged the four locations shown in Figure 1. These data will be used also for high resolution digital map creation (orthophoto) Digital Surface Model (DSM) and 3D models of the acquired areas. Information on where to find down-sampled video for two of these locations (Accumoli and Pescara del Tronto) are provided on the Central Italy Earthquake event page within the GEER Association website ([www.geerassociation.org](http://www.geerassociation.org)). Figure 6 shows aerial photos taken by drones at Accumoli (Figure 6a) and Pescara del Tronto (Figure 6b).

Observed landslides were mainly small rock failures (wedge slides, topples and slides in intensely fractured/weak rocks) which very often generated rockfalls. One of the largest failures occurred on a slope that, in the past, was involved in similar instability phenomena (Pescara del Tronto, just above the Salaria State road, Figure 6b). In several instances (specifically Tufo, Pescara del Tronto and Accumoli, Figure 6a), retaining structures underwent displacements and rotation (toppling) with consequences to the backfill and hence to the areas behind (including roads).
