## Seismic Performance Assessment of Existing Steel Buildings: A Case Study

**Keywords:** Buildings, Frames, Seismic assessment, Performance criteria, Earthquakes.

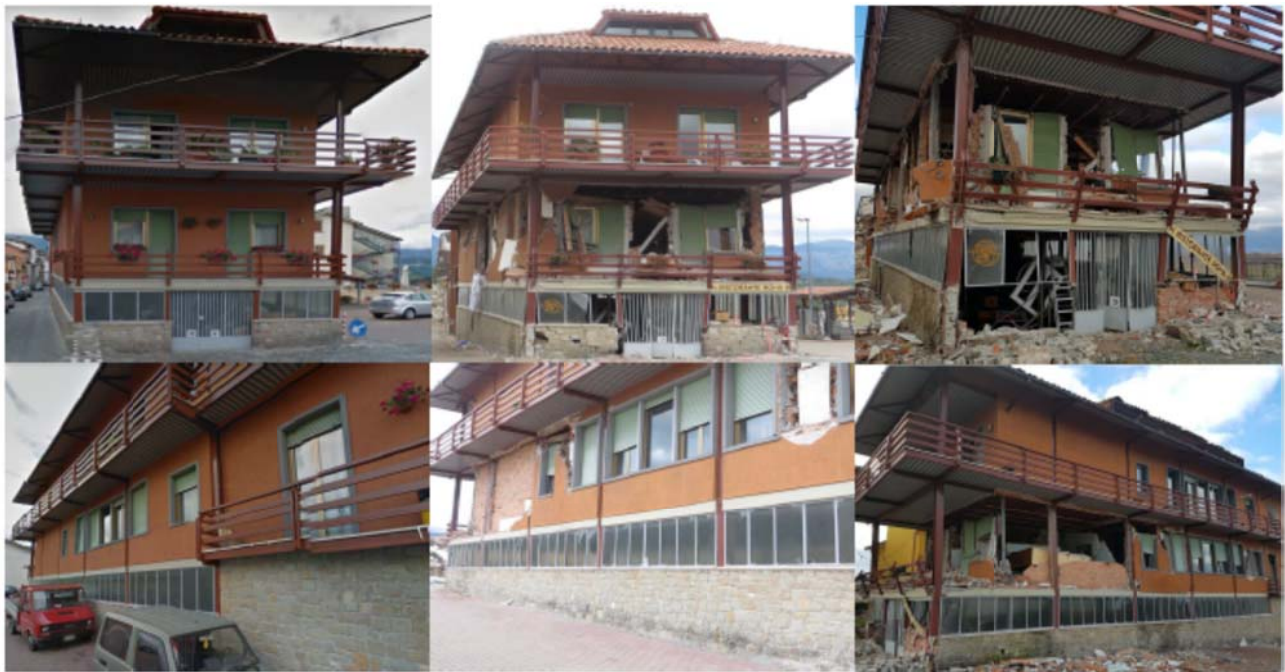
24<sup>th</sup> August and 30<sup>th</sup> October 2016 earthquakes. Figure 1 shows the response of the sample structure in the aftermath of the seismic sequence.

Figure 1. – Seismic response of the sample building: before the earthquakes (left), after the 24th August event (middle) and after the 30<sup>th</sup> October 2016 (right).

In the aftermath of the 24<sup>th</sup> August event, it was observed that the non-structural components, especially the masonry infill panels, and the architectural finishes, e.g. the plaster, were significantly cracked. Some damage was also detected in the columns, particularly at the beam-to-column connection.

After the 30<sup>th</sup> October 2016, the steel frame experienced large inelastic demand and the structural and non-structural damage became widespread. The columns suffered localized damage due to the presence of infill panels which generated high concentrated stresses at the beam-to-column connections. Out-of-plane failure of the masonry infills were detected along the perimeter of the frame. Some joists at the openings collapsed. The steel building has experienced significant lateral drifts but the residual strength of the structure was sufficient to carry the gravity loads and prevent the global collapse.

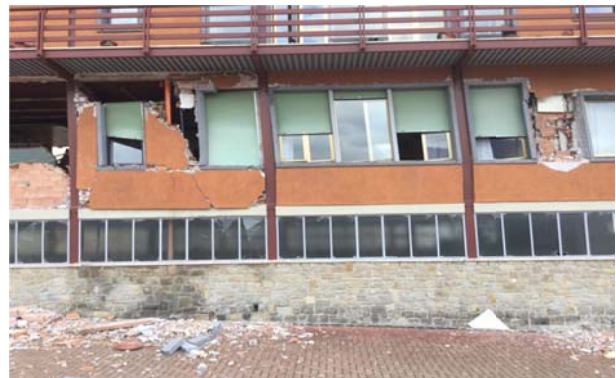
Figure 5. – Damage in the columns of the first floor of the building

The effects of the infill panels on the seismic behaviour of the buildings is evident, especially in the X-direction, where the infill panels were actually subjected to the highest damage level. While base-shear and displacement increase initially in a linear manner, infill panels damage initiates approximately at a displacement of 1cm until failure that occurred at a control point displacement of 4cm. As anticipated, a significant drop in the lateral resistance is also observed. Upon exhaustion of the infill panel resistance, the yielding of the steel elements takes place leading to a force increase due to the hardening effect. The absence of damage in the infill panels in the Y-direction, observed during the in-situ inspections, is verified in Figure 4, where the contribution of the infills is confined in the elastic range and the force increases monotonically. Figure 4 further shows the distribution of the plastic hinge for life safety (LSL) and collapse (CLS) limit states, respectively. It is interesting to note that at CLS the damage is confined in the columns at first floor that were subjected to a significant damage (i.e. important yielding conditions). This is in agreement with the damage observed during the in-situ inspections (*see* also Figure 5).

Figure 11, where the most damaged infills are clearly located in the first and second floor of the building. This result fits closely with the observed response of the real building, as shown in Figure 5. The damage in the steel elements is also limited at first and second floor, similarly to the real damage pattern observed on site (*see* also Figure 5 and Figure 11).

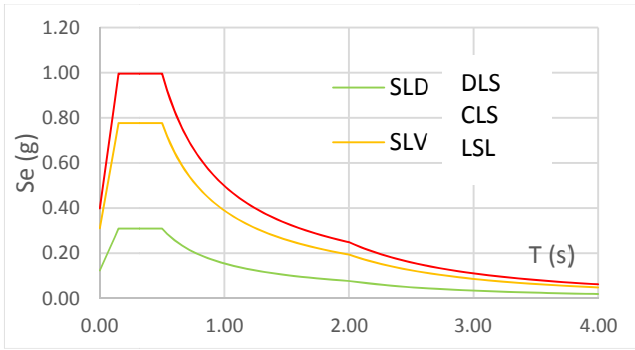
In order to calculate the seismic demand of the structure corresponding to the above-mentioned limit states, the N2 method has been herein adopted [24]. The corresponding elastic response spectra are illustrated in Figure 6. The demand in terms of base shear and displacement is reported in Figure 7 for the different limit states. It can be noticed that the damageability limit state (DLS) is, as expected, located close to the yielding of the building, whereas CLS is located in proximity of the infill panel failure (Figure 8). This is again fully compatible with the in-situ observations of severe infill damage.

Figure 6. - Elastic spectra for different limit state according to Eurocode 8.

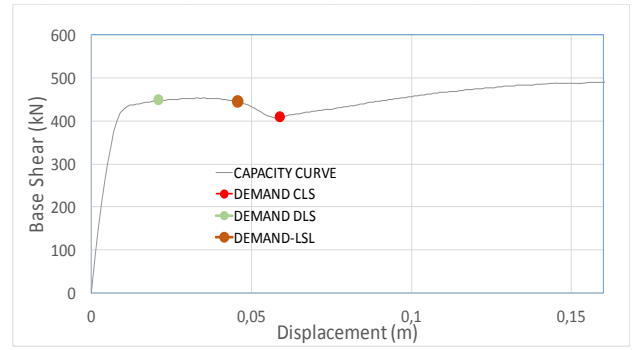
Figure 7. - Seismic Demand for DLS, LSL and CLS.

The response of the building evaluated with the time-history analysis matches the results of the nonlinear static pushover analysis, presented in the previous section. For example, the maximum base shear, evaluated using either static (Figure 7) or dynamic analysis (Figure 10b), is about 470 kN. This is mainly due to a similar frequency content and amplification of the response spectra. The damage pattern determined with the time-history analysis is also similar to the predictions obtained with the pushover analysis. A significant contribution of the infill panels has been observed, as also displayed in Figure 12, where an example of cyclic response of an infill panel is provided. The complete damage pattern of the infill panels is shown in

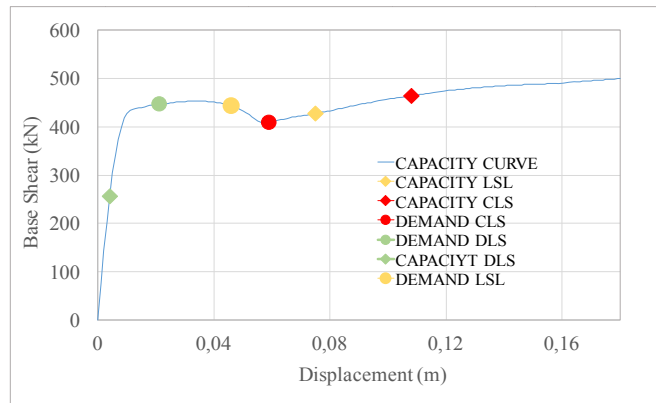
Figure 9. - Comparison between demand and capacity at different limit states

Given that all members of the structure are deemed as Class 1, the values of the first row in Table 2 have been used. The fragile mechanisms are instead checked in terms of shear strength. Given the particular type of mechanism, in what follows, only the ductile mechanisms will be commented. Figure 9 shows the comparison between capacity and demand. It can be noticed that while LSL and CLS limit states are fully

fulfilled, the serviceability condition is by no means satisfied. More precisely, Eurocode appears to be particularly conservative. DLS should refer to a damage condition for which the nonstructural elements would be already damaged without important damages in the structural members. In the case study, the capacity refers to a condition of both structural and non-structural elements undamaged.

To evaluate the reliability of the Eurocode 8- Part 3 [23] in the assessment of existing steel structures, the seismic capacity at the above-mentioned limit states has been calculated and compared with the demand of Figure 9. In this respect, Eurocode 8- Part 3 [23] prescribes that both ductile and fragile limit states should be verified. Concerning ductile limit states, Eurocode imposes, for different limit states and class of cross section, the chord-rotation thresholds summarised in Table 2. The capacity is then quantified in relation to the yielding chord rotation, which can be calculated as suggested in [25]. In particular, eq. (1) can be used for beams and eq. (2) for columns, where  $M$  is the plastic moment,  $L_b$  and  $L_c$  are the lengths of the beams and columns, respectively,  $I$  is the moment of inertia,  $E$  is the elastic modulus,  $N_{ed}$  and  $N_{p,Rd}$  are respectively the demand and the ultimate value in terms of axial force.

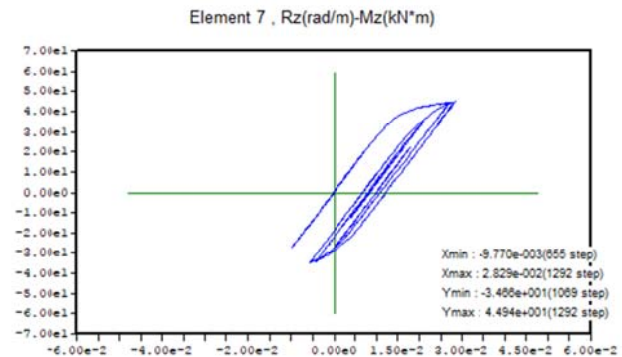
Fig. 12 – Moment-Curvature of a column at first floor
