EXPERIMENTAL INVESTIGATION OF ENHANCED SEISMIC PERFORMANCE OF STONE MASONRY USING LOW-COST RETROFIT

V. Manandhar ¹, H. Shrestha ², N. P. Marasini ³, R. Prajapati ⁴, R. Guragain ⁵, R. Chaulagain ⁶, N.
A. Alexander ⁷, F. De Luca ⁸, N. Giordano ⁹, A. G. Sextos ¹⁰

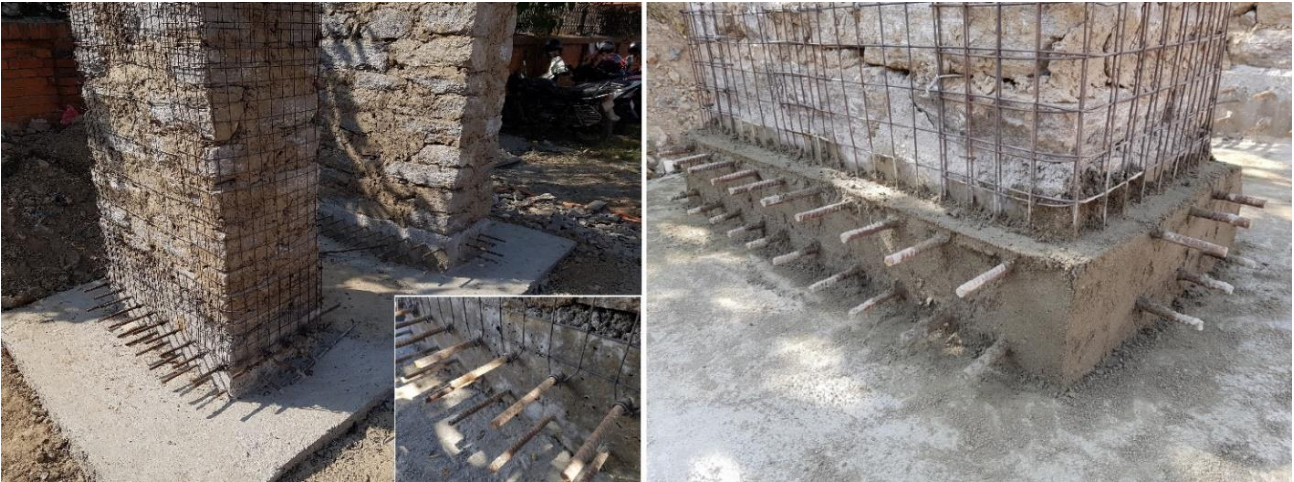
Figure 4 Wire mesh tied and welded to the rebar of the pedestal (left); Connections covered with 50mm of 1:6 plaster (right)

A reinforced concrete foundation was constructed to support the reaction steel column. For the test walls, a 400mm thick raft-like stone foundation was constructed that prevented any kind of uplifting. Two M20 RC pedestals were designed to serve as a base for each wall. Multiple protruding rebar were left out for the wire mesh to be connected. To secure the pedestals to the foundation and prevent any upliftment or damage, several inverted U-shaped transverse reinforcements were provided throughout the length of the pedestals. The U shaped rebars were continued to the base of the foundation and anchored with 100mm thick M20 concrete. This comprehensive design and construction approach ensured both the stability and structural integrity of the reaction column and the pedestals.

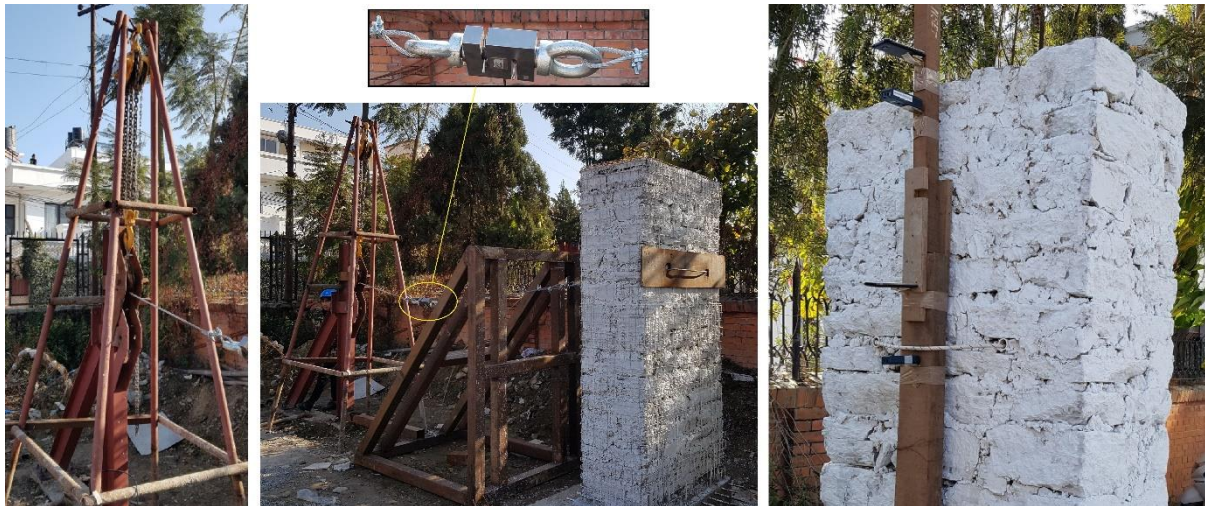
Figure 5 Chain pulley arrangement (left); Pull-down setup for retrofitted wall (mid); Lasers placed pointing towards the retrofitted wall, using the non-retrofitted wall as support (right)

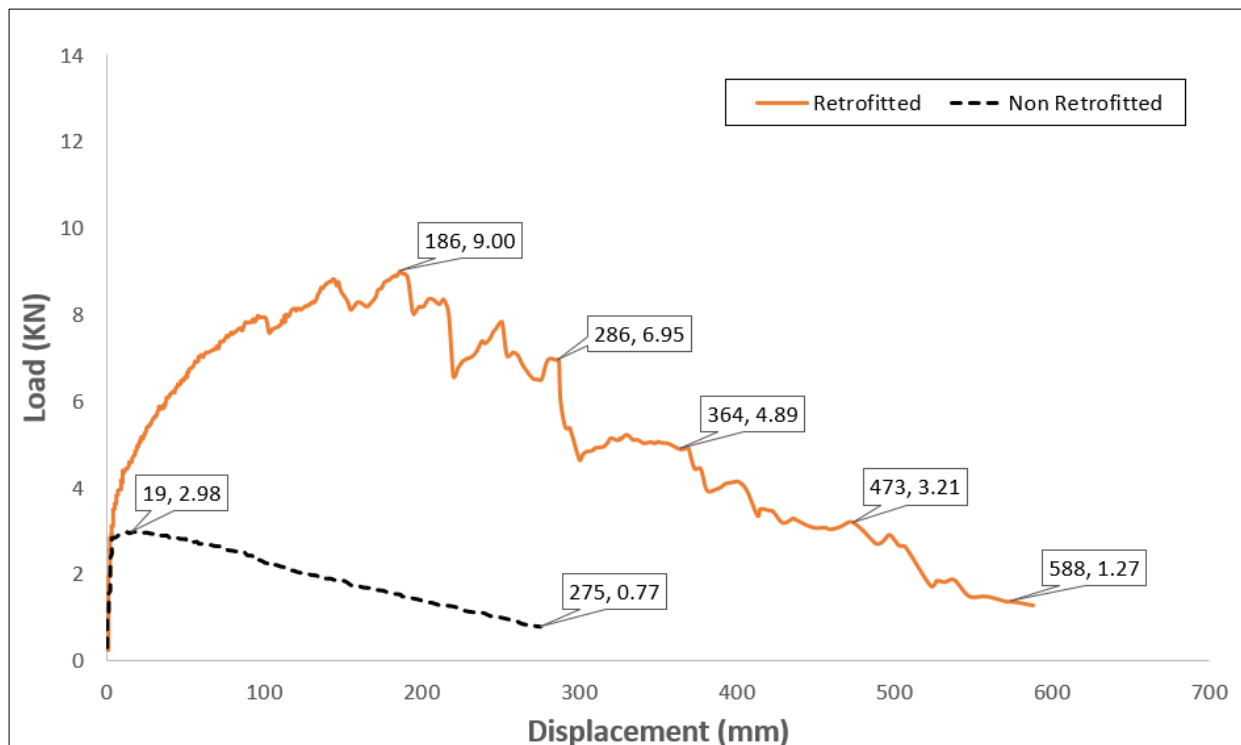
Figure 8 Load vs Displacement curves of the Retrofitted and Non-retrofitted walls of the Second Test

The retrofitted wall exhibited a maximum load of 9 KN, whereas the non-retrofitted wall registered a load of 2.98 KN. Similarly, the ultimate deflection measured 275 mm for the retrofitted wall and 588 mm for the non-retrofitted wall. The initial loading phase displayed high stiffness, and the formation and propagation of initial cracks followed a pattern similar to that observed in the first test for both retrofitted and non-retrofitted walls.

Gradual failure of welds at various sections of the wire mesh led to abrupt drops in the load vs. deformation diagram. The behavior of the non-retrofitted wall in the second test closely matched that of the first test, with only a 6.4% difference in peak load (2.98 KN in the second test vs. 2.8 KN in the first) and a 2.18% difference in ultimate deflection (275 mm in the second test vs. 281 mm in the first). However, the retrofitted wall in the second test exhibited a notable deviation, with a 24.18% lower peak load (9 KN in the second test vs. 11.87 KN in the first). This discrepancy warranted further investigation to understand the factors contributing to this difference in performance.

The main factor that could be linked to this outcome was the variation in the failure mechanism of the retrofitting element. It was noted that the wires became dislodged from their anchorage point and were unable to achieve their full capacity due to the absence of welding to the pedestal rebars. This underscores the significance of ensuring the proper anchorage of these retrofitting elements to the foundation. In practical implementation, this is typically accomplished by embedding the retrofitting element into a reinforced concrete band.

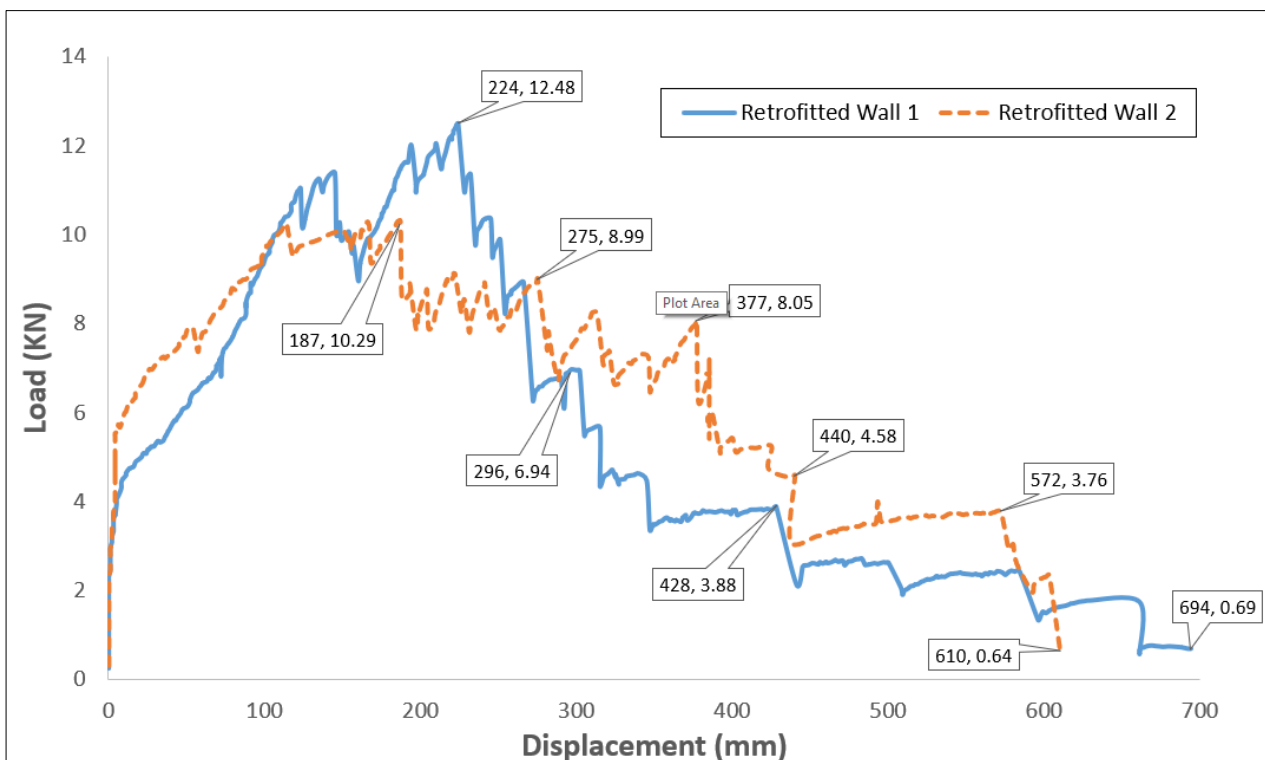
The third set of tests was conducted in April 2021, wherein both walls underwent retrofitting. The welded wire mesh was securely affixed and welded to the pedestal to prevent connection failure, mirroring the approach used for the walls in the first set. However, the connection was coated with a rich plaster mixture of 1:3. The construction masons were the same as those in the second set, but different technicians were responsible for retrofitting the walls this time. Nevertheless, the quality of the finish was maintained at the same standard as in the previous tests. The maximum loads observed were 12.48 KN and 10.29 KN, with both walls exhibiting an ultimate deflection exceeding 600mm, specifically 610mm and 694mm. While there was a difference in peak load resistance between the two walls, the energy absorbed by them was nearly equal, as illustrated in the figure below.

Figure 9 Load vs Displacement curves of the two retrofitted walls of the Third Test

The second wall, which had a peak load of 10.29 KN, ultimately performed more work, totaling 3993.71 KNmm. In contrast, the first wall, with a peak load of 12.48 KN, completed 3745.26 KNmm of work (6.22% less). Both walls were found to absorb comparable amounts of energy, despite having different peak loads. Additionally, the failure mode observed in these walls was consistent with what was observed in previous tests. It was concluded that in both walls, the wire meshes failed due to rupture, rather than experiencing anchorage failure at the base.

The distinction in the characteristics of the curves for the two retrofitted walls in the last test also demonstrates how the lateral load plot, depicting the behavior of masonry walls, can vary, despite all physical parameters and failure patterns of the two walls being essentially identical.
