Nepalese School Building Stock and Implications on Seismic Vulnerability Assessment

Keywords: Nepalese school building; Earthquake damages; Structural typology; Vulnerability assessment.

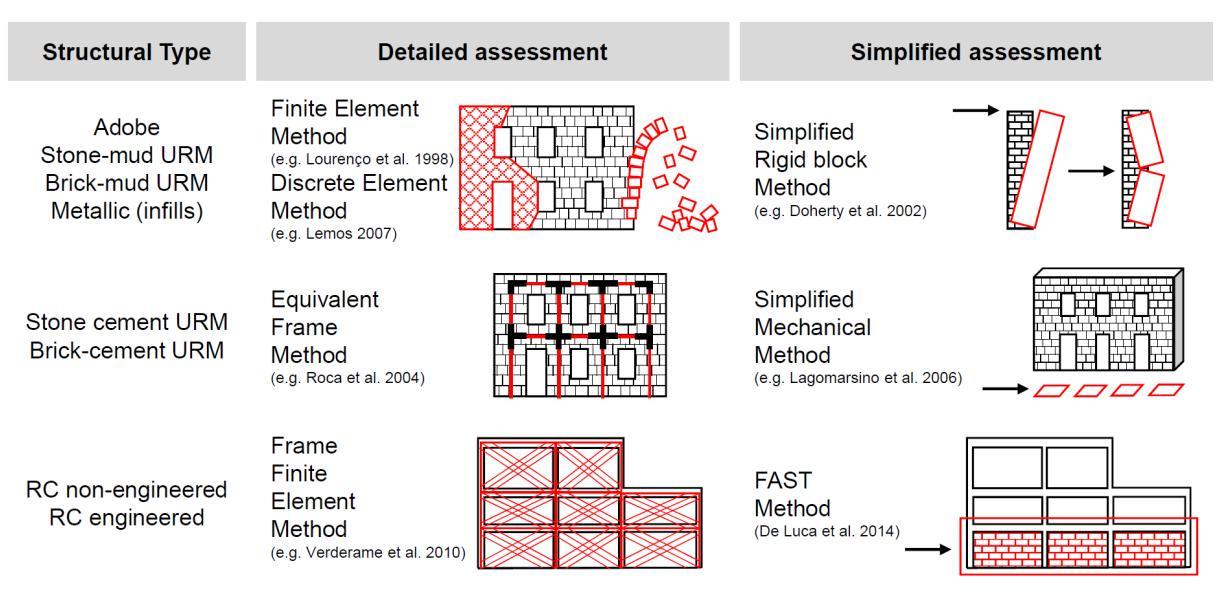
Fig. 1. Flow-chart of detailed (single building) and simplified (portfolio) assessment for Nepalese school building stock.

A schematic flow-chart of the possible methodologies for detailed assessment (building scale) and simplified assessment (regional scale) is reported in Fig. 1.

From Tables 2 and 3 the following assessment suggestions for the different structural typologies are outlined:
